Newsletter Newsletter

MASTER TOOL, LLC
Subsidiary Sumitomo Electric Hardmetal Corp.
INNOVATORS OF SPECIAL DESIGN & BUILD TOOLING SYSTEMS
P.O. Box 189 * 210 River Street * Grand River, Ohio 44045
Phone (440) 354-0600 * Fax (440) 354-6372 * Email: master@mtctools.com

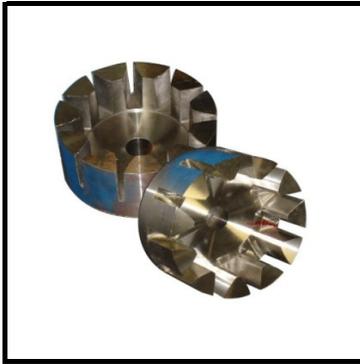
Fig. 1

A few months ago, Master Tool was asked to develop a series of hollow mills to machine vanes for a pump manufacturer in the Midwest (see rough and finished parts in Fig.1).

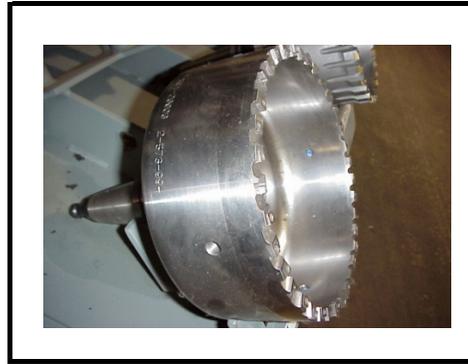
Fig. 2

The Master Tool design engineers were able to design a cutter that always had an insert engaged on the part and had four (4) cutting edges. The customer purchased a cutter on a trial basis for their most popular vane size.

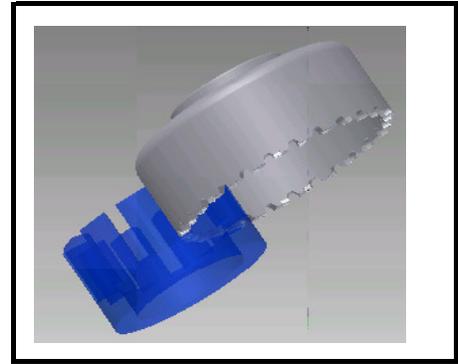
Fig. 3

These vanes would be machined on a horizontal machining center by feeding the milling cutter down onto the part (not unlike a hole saw) (see Fig.3). The milling cutter would machine two vanes at a time - all of the way to the bottom of the part. The part would then be indexed on the table to the next two vanes. and continue until all of the vanes are machined.
